The 1917 tsunami inundation in Samoa: Discrepancies in modelled-to-observed event reconstructions

January 20, 2023

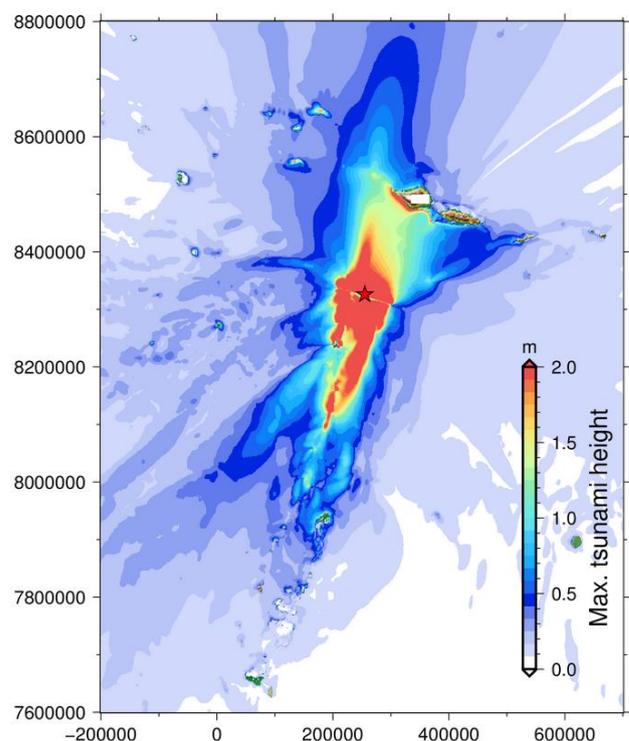
Figure 1: 1917 tsunami model in Samoa

In order to overcome this lack of data, this work has modelled the aspects of the 1917 tsunami event, using available historical records. The tsunami model used an earthquake initiation, propagation along the Tonga Trench and generated inundation footprints for the islands of Samoa. Then using this model output, the impact in present-day Samoa was determined to estimate the likely exposure and damage to buildings within the inundation zone.

The study identified a number of inconsistencies between the inundation zone and the anecdotal evidence recorded at the time of the event. In addition, discrepancies were identified between the model and the records from tide gauges in Apia harbour at the time. These recorded a fluctuation of the sea five minutes after the 1917 earthquake.
