# A novel radiographic projection for the detection of a scapula body fracture in a Thoroughbred foal

Key Points: horse, scapula, fracture, foal, radiograph.

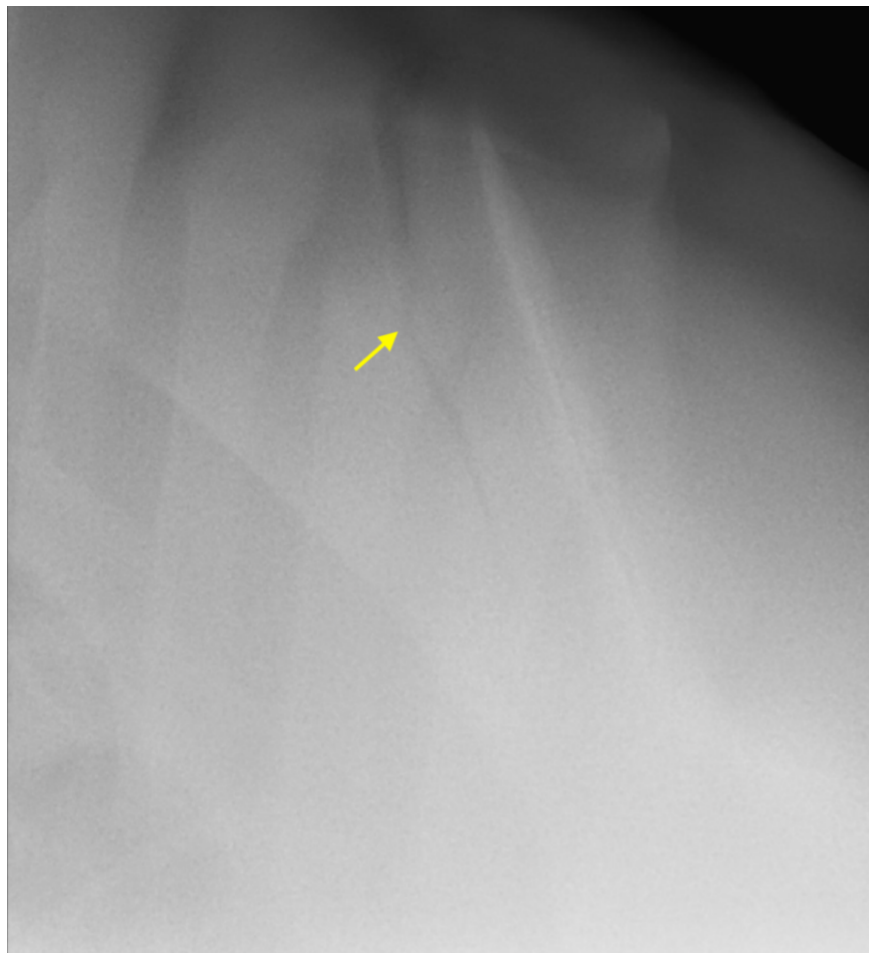
The foal was sedated with xylazine (0.5 mg/kg IV) and radiographs of the left scapulohumeral joint were obtained due to high suspicion of fracture in the proximal forelimb, with a low-output radiographic generator and direct digital radiography (Enduras Wireless- MinXray, Cuattro Hub- Heska). Standard radiographic projections, including mediolateral (ML) and cranial 45deg medial-caudolateral oblique (Cr45degM-CaLO) views of the left scapulohumeral joint were unremarkable (Fig 1). A dorsal 45deg lateral-ventral lateral oblique (D45degL-VLO) projection was obtained with the leg in flexion and the cassette placed closest to the affected limb, with the radiographic beam at 45deg with respect to the sagittal plane of the horse (Fig 2). This image revealed a longitudinal fracture of the infraspinous fossa, coursing from the caudal border of the scapula, proximal to the neck, through the infraspinous fossa, parallel to the spine, and exiting through scapular cartilage (Fig 3). Ultrasound examination of the left scapula, performed with a multi-frequency

(CT) examination. Prohibiting factors of such examination include patient size as well as equipment access, owner funds, and the associated risks of general anesthesia. With standard radiographic views of the shoulder, the diagnosis would have not been reached in this case. In cases where the standard radiographic views are non-rewarding and there is an indication of proximal limb lameness such as crepitus, reduced cranial phase of the stride, dropped elbow, or pain on palpation, an additional skyline view of the body of the scapula may be indicated. The skyline radiographic view described in this report was sufficient for the diagnosis and development of a treatment plan. To the knowledge of the authors, this radiographic projection has not yet been described in the equine literature. This radiograph was captured with a low-output portable generator making the acquisition of this image achievable to field practitioners. Superimposition of the opposing limb and thoracic structures makes the diagnosis of a dorsal scapular fracture difficult with traditional radiographic views. In neonatal foals, a lateral view of the cranial thorax may allow for visualization of the entire scapula, however, the described oblique view (D45oL-VLO) provides the advantage of anatomic isolation.

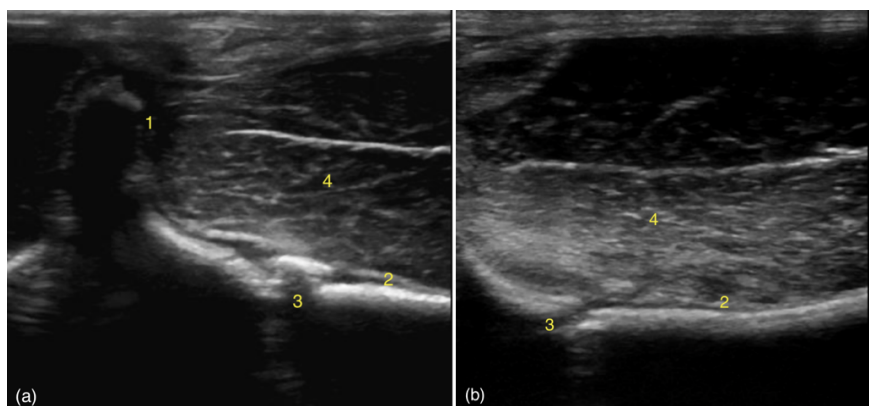
linear probe (GE Logiq E, 3-10MHz), identified a defect in the surface of the infraspinous fossa, with no displacement of the fracture in the frontal plane (Fig 4). Similar radiographic evaluation performed six months later revealed complete healing of the fracture.

With suspected fractures of the equine proximal forelimb, ultrasound has been described as a valuable diagnostic tool (Davidson and Martin, 2004). Ultrasound has the limitation of only being able to highlight the lateral aspect of the scapula and centers of ossification or normal roughening of the bony surface can be confused with a fracture line. While the exact configuration of a fracture cannot be determined by two-dimensional imaging alone, radiography was able to highlight the displacement in the cranial-caudal plane, while ultrasonography was performed as an adjunctive diagnostic tool to evaluate displacement of the fracture in the frontal plane and the concurrent soft tissue damage. Nuclear scintigraphy has been reported to have little value in the diagnosis of lameness in foals due to a diffuse increase in radiopharmaceutical uptake of the normal physes (Hunt, 2011).
